Bridges after the fire – Experiences, tests and repair methods

4.2. Fire of the bridge over the M1 highway, Hungary

4.3. Fire of the bridge over the highway M6, Hungary

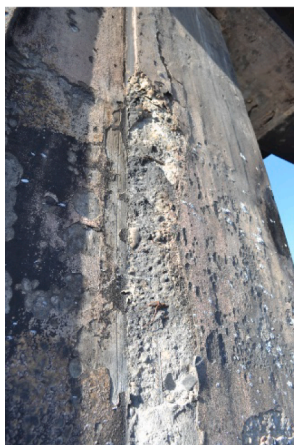
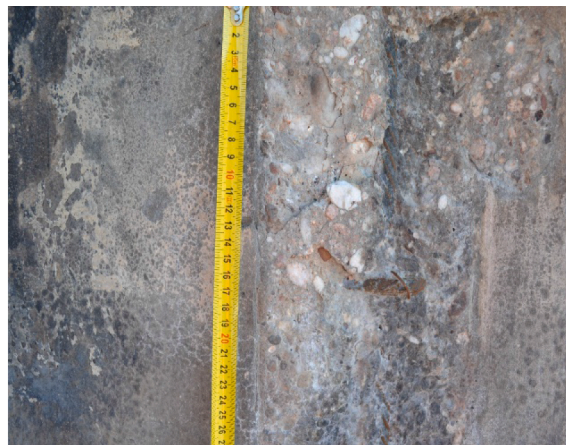
Fig. 3. Damage of the bridge piers after the fire (31/3/2017).

After the visual examination of the bridge piers, we determined that the heat load struck the slope side of the pier more strongly than the route side. The concrete surface is whitened in a clearly visible area because the highest flame effect was there (Fig. 3). Due to the high temperature on the slope side of the pier, the corners of the concrete

Slope side of the pier

The spalled and discoloured concrete

At the bridge pier and at the header, the concrete was damaged, cracked or spalled in several places. These parts needed to be repaired.

The surface of the concrete was knocked, and the loose parts were removed. The sooty concrete surface was cleaned with chemicals as this neutralized the harmful effects of soot.

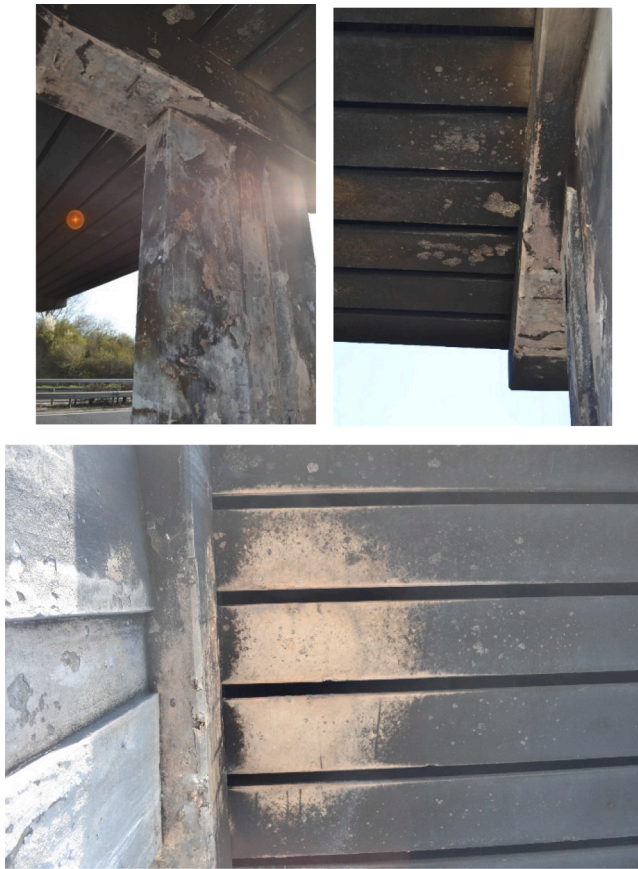
Fig. 4. Header and main beams after the fire (31/3/2017).

were detached (Fig. 4). The surface of the concrete became pink at the outer few millimetres. It suggests that the temperature was above 500°C (Fig. 4). The salt protection coating on the slope side of the bridge pier was burnt in many places. However, the cementitious layer under the salt protection coating is only slightly damaged by the heat load. On the route side of the bridge pier, the plastic coating did not burn down completely. It cracked and spalled in some places. It suggests that the maximum temperature of the heat load was about 200°C .

On the fire side of the beam, the surface of the concrete has been spalled in some places, especially at the corners of the element (Fig. 4). The surface of the main structural elements became sooty. In the slope-side opening (1–2 opening) the concrete cover of the beams spalled in one or two places. On the side of the route, the remaining formwork

ignited. Here, the surface of the beams was whitened, and the heat load on the beams was probably the highest here.

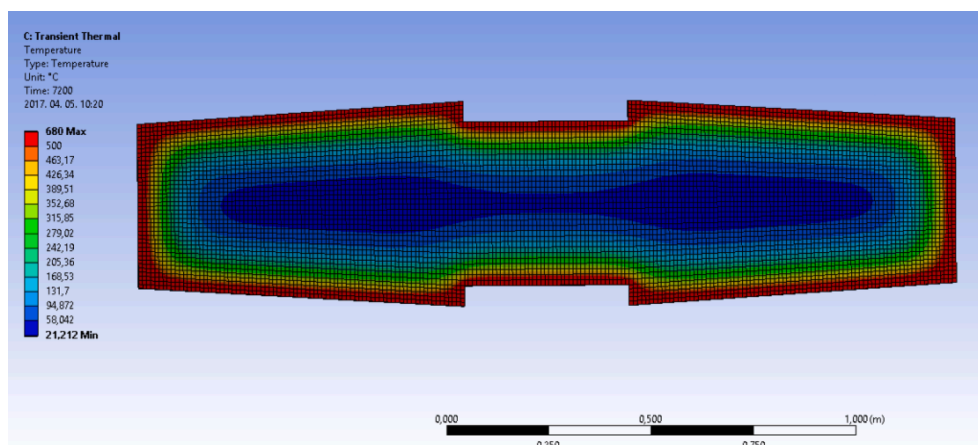
Fig. 5. Modelling the isothermal lines formed in the column in the second hour of fire.

Fig. 5 shows a cross-section of the column with the isotherm lines formed during the fire in the second hour. Temperature range above 500°C is indicated by the red colour.

Based on the finite element modelling, the depth of the burned part (over 500 °C) in the cross-section of the column is 5 cm maximum at the corners and 2 cm at flat surfaces after two hours of fire load.

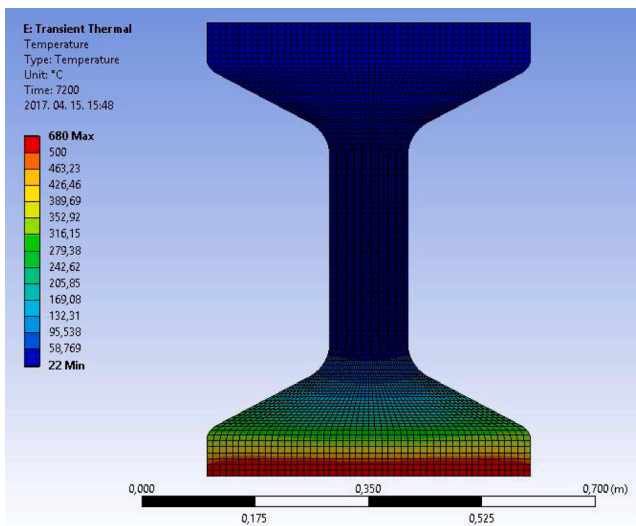
Fig. 7. Modelling of the isothermal lines formed in the EHG beam in the second hour of fire.

Based on finite element modelling, the depth of the burned part (over 500 °C) in the cross-section of EHG beam is 2,5 cm maximum, at the flat surface in the lower zone after two hours of fire load.

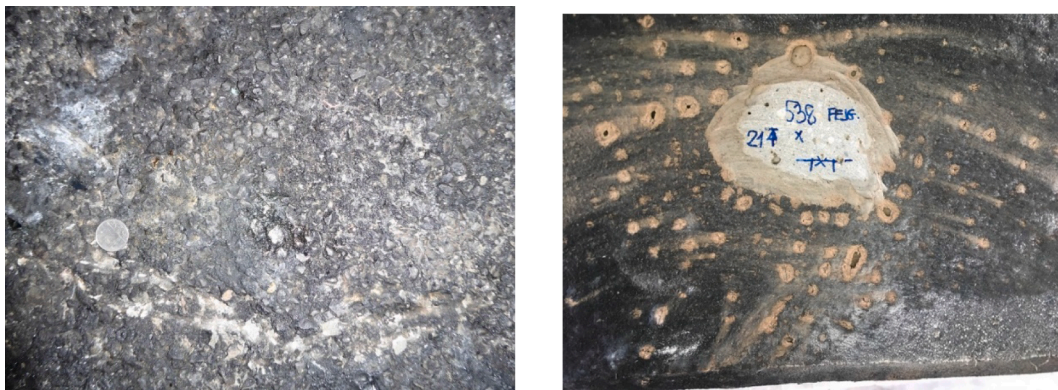
Fig. 10. Scaled B-4 salt protection coating and the polished concrete surface underneath (1/6/2017).

The salt-protection layer was scaled by the fire on the pier and the header (coated with B-4 plastic cement-based). On-site examinations showed that the concrete layers under the salt protective coating are barely damaged by heat. The sooty coating was cracked and detached at some points but was not completely burned down (Fig. 10).

Based on the rebound hammer test (estimated concrete strength on the surface was C16/20 on the beams and piers) and the condition of the coatings, the maximum heat load temperature of the B-2 pier and B-header was approximately 500 °C. Based on it, the zones of the cross-section affected by strength loss in these structural elements were negligible (about 4–5 cm).

- I: The salt-protective cover on the surface of the **B-2 bridge pier and B-2 header** became flaky as an effect of the fire. The sooty salt-protective coating was cracked and spalled in some places, but the plastic coating was not completely burned. The strength of the concrete layer under the salt protective coating has decreased as an influence of the heat. However, the surface is suitable for a new salt-protective coating. Based on the control calculations, the carrying capacity of a pier cross-section with concrete cover is safe even after the fire. *Suggestion for the repair:* The standard salt-protective coating of the B-2 pier (B-4 coating) shall be removed on the sides affected by the fire and restored to its original condition.

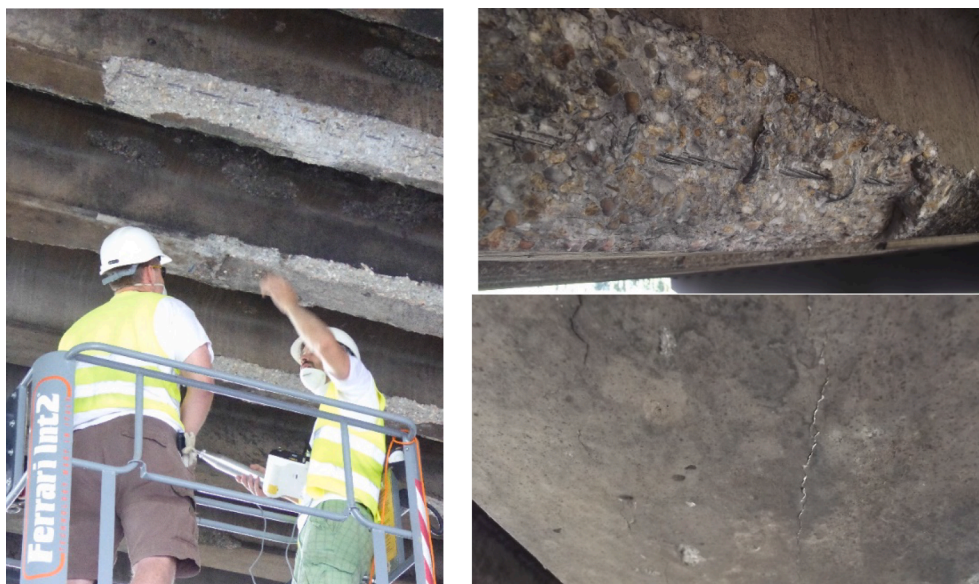
Fig. 11. Damage of the bridge beams and the sampling (1/6/2017).

The concrete cover spalled at the lower edges of the web of four of the fire affected bridge beams 3–5 m away from the header four of the

In case of the most heavily damaged bridge beam, the concrete cover on the lower edges spalled significantly, and longitudinal cracks were formed. Non-destructive strength estimation, thermal modelling and static monitoring of these beams were required. In the case of the middle beams, the amount of spalling was higher. At the spalling, the grains of the aggregate were ruptured, so it suggests that the concrete strength was higher in case of these beams. For the other three beams, the cross-section was only slightly damaged. The concrete cover spalled only at the edge from the side of the fire. A longitudinal crack was observed in the middle of the lower flange of the beams. During the phenolphthalein measurement, the phenolphthalein solution was sprayed onto the freshly peeled and professionally dusted concrete surfaces. At the two sampling points, the sprayed solution immediately turned to pink colour on the surface of the cracked cement stone. The thickness of carbonated concrete layers of the FPT beams is negligible (<1mm). The steel bars were not reached at any of the test areas.

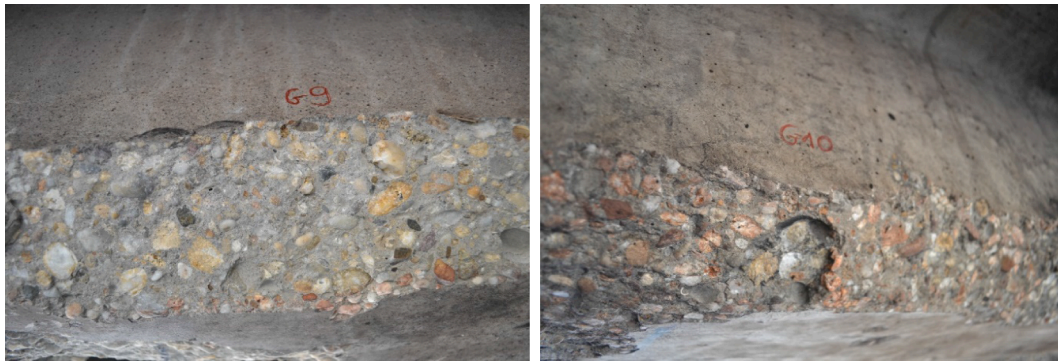
Fig. 12. Surface of the spalled concrete and the broken aggregate grains. (12.07.2017).

The spalling occurred at different lengths on the beams, typically in right-angled triangle cross-sections of approximately 12–15 cm legs. At the border, longitudinal cracks could be observed. These mark the borderline of the concrete parts, which did not spall but can be easily detached with a hammer (Fig. 12).

The spalling of the lower edges of the bridge beams can be explained by the high concrete strength (C50/60) and the sudden high vapour pressure due to the associated concrete structure. Based on experience and the case study of the fire, the edges of the concrete were spalled around 10 min from the start of the fire.

- III: On the **G-7 to G-12 bridge beams between B-C supports**, there are visible damages. In addition, there was also concrete spalling due to the vapour pressure and the associated longitudinal cracks. No additional cracks (for example due to traffic reasons) are visible after the fire. The level of carbonation and chloride penetration in the beams is negligible. In the zones affected by spalling and in other parts affected by heat, the strength of the concrete was reduced by an average of 40 %, and the strength of

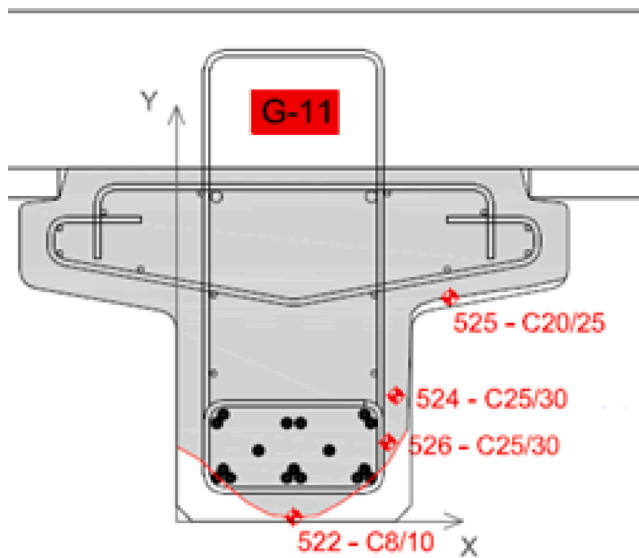
Fig. 13. Cross-section of the most damaged beam (in red). (For interpretation of the references to colour in this figure legend, the reader is referred to the web version of this article.)

A finite element model was created with the ANSYS Workbench R16.2 software. The goal of the development from the models was to model the heat transfer in the cross section. The thermal conductivity parameters of the concrete were calculated according to the Hungarian standard [22]. The duration of the fire was recorded as half an hour based on the disaster management report, and the video record and an external fire curve was used. We used the most damaged beam (G-11) during the modelling. The damage level of the beam is shown in Fig. 13.
