An Experimental Study of Smoke Movement in a Pressurised Smoke-Free Staircase

Keywords: pressurised staircases, differential pressure measurements, Pressure Differential Systems (PDS), smoke movement

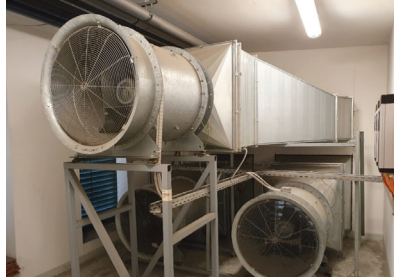
Figure 3: Staircase pressurisation fans on the top floor
 Source: compiled by the authors

The staircase pressure is controlled by PI control with a proportionality factor of 0.5 and an integration time of 10 s, which was not changed during the measurements. The set point was 70 Pa, with a minimum frequency of 10 Hz, which was the same as the start frequency. The designed air volume of each fan was 28 000 m³/h each, with a total pressure of 350 Pa.

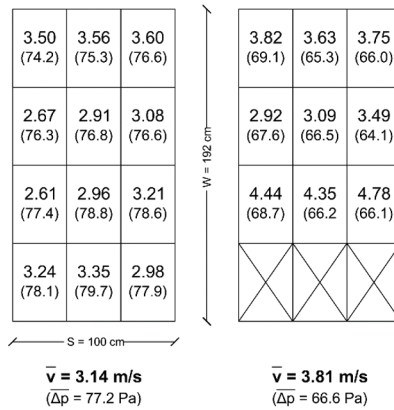
Figure 5: Measured air velocity and pressure difference through the air release opening with 100% and 25% free area of the vent

Air measurements on the air release opening to the open air were taken at 12 points in the uncovered configuration and at 9 points with the damper at 25% covered. At each point, one measurement sequence was 30 s, with a recording frequency of 1 Hz. The air velocities measured at each point, and the pressure difference between the two sides of the damper while measuring the air velocity, are illustrated in Figure 5. The free aperture area is taken into account by a factor of 0.8.

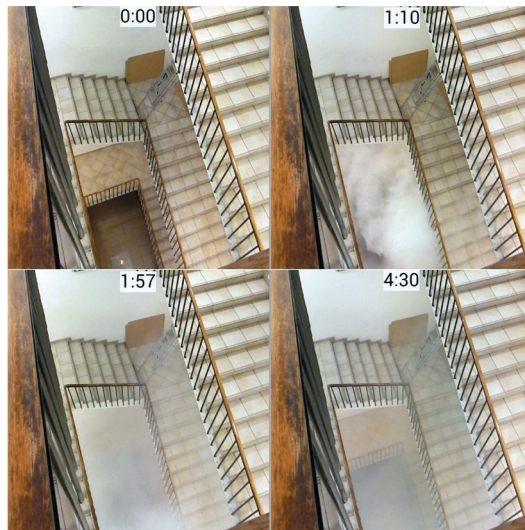
Figure 6: Test 1, observation from the ground floor

Figure 7: Test 1, observation from the 2nd floor

In the first experimental arrangement, the smoke candle was installed at basement level, below the air release opening, about 8 meters below it. Within a few seconds, the developing smoke enveloped the staircase to a height of approximately 3 meters from the floor level. At the same time, an intense flow of smoke was observed from the pressurised space towards the pressurised lobby at basement level. The smoke flowing through the gaps around the door was stirred up and diluted by the air inlet to the hallway. The optical smoke detector located here gave a signal 55 seconds after ignition. The smoke in the lobby airspace then leaked into the lift shafts and towards the accommodations.

In the staircase, smoke was flowing upwards from the lower part of the staircase and smoke was also flowing into the pressurised lobby on the ground floor through the doors from the staircase to the lobby. The optical smoke detector located in the ground floor lobby gave a signal at the 106th second.

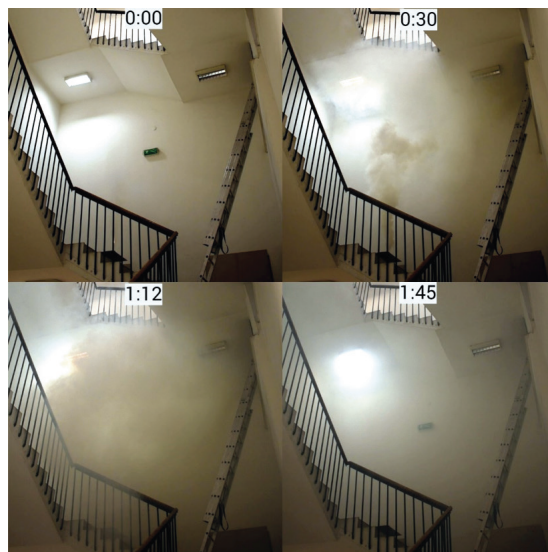
Figure 8: Test 2, observation from the ground floor

Figure 9: Test 2, observation from the 2nd floor

In the second experimental set up, the smoke candle was installed on the mezzanine rest in front of the air release opening, 2 meters below it. Some of the evolving smoke was released into the open air, but there was a separation in the open well, which caused the smoke to spread towards the lower levels. After the release ceased, the resulting smoke mass descended as a vapour to the lower floors, where a significant amount of smoke was released through the door gaps into the ground floor and basement lobbies.

The investigation showed that the smoke candle placed closer to but lower than the damper created more favourable conditions in the staircase, but still a significant amount of smoke was released into the lower, unflushed area. There was no smoke visible to the senses above the air release opening, but there was smoke leakage into the firefighters lift shaft. The optical smoke detectors gave a later signal than in the first test, due to the fact that part of the smoke from the staircase had escaped through the dampers to the outside, and therefore the smoke concentration in the lobby was slower to develop.

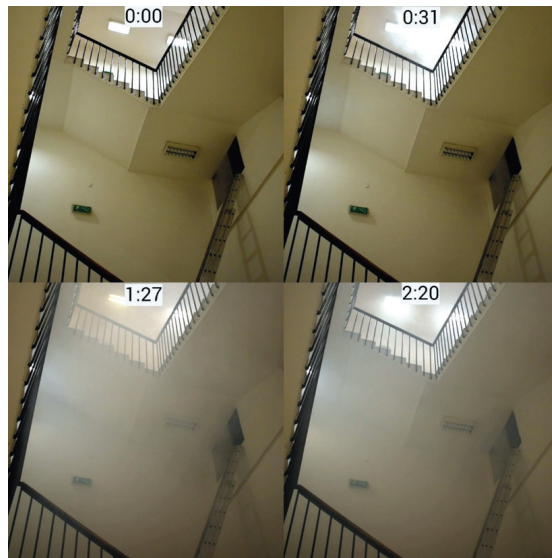
Figure 10: Test 3, observation from the ground floor
Source: compiled by the authors

Figure 11: Test 3, observation from the 3rd floor
Source: compiled by the authors

In the third experimental setup, the smoke candle installed in the rest area between floors 2-3 was located above the air release opening, about 2 m above it. The smoke initially started to flow down the staircase, and then downward flows were observed in the open well. A significant part of the smoke escaped to the open air through the damper, but the outflow was adversely affected by the fact that the opening to the open air was partially covered horizontally by the stairway. The remainder of the smoke descended down the open well as in the second experiment. In the second floor lobby, smoke ingress was only briefly detectable by the senses. In the lower level lobbies, the optical smoke detectors gave a significantly later signal, which can be explained by the dilution of the smaller amount of smoke. The firefighters lift shaft was leaking a detectable amount of smoke. It can be seen that during the smoke development above the air release opening, a significant part of the smoke generated was vented outdoors through the damper. The remainder descended in the open well, but at a lower volume and density compared to the first and second experiment. The levels above the vents remained smoke-free, but smoke reached the lower levels. The small amount of smoke that entered the lobby slightly penetrated the firefighters lift shaft.
