Bridges after the fire – Experiences, tests and repair methods

4.2. Fire of the bridge over the M1 highway, Hungary

4.3. Fire of the bridge over the highway M6, Hungary

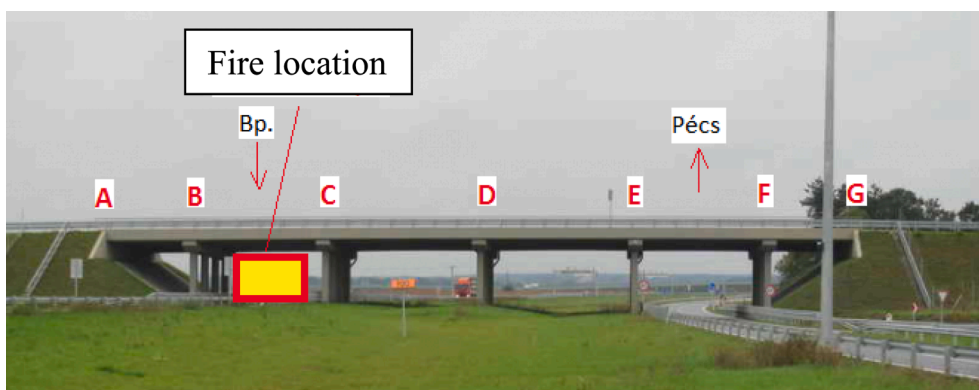
Fig. 8. Side view and location of the fire (from Budapest).

The bridge over the highway M6-M60 was built in 2010. The side view of the bridge is shown in Fig. 8. The span of the section affected by the fire was 12.41 m. This involved 25 FPT-45/11.80 beams.

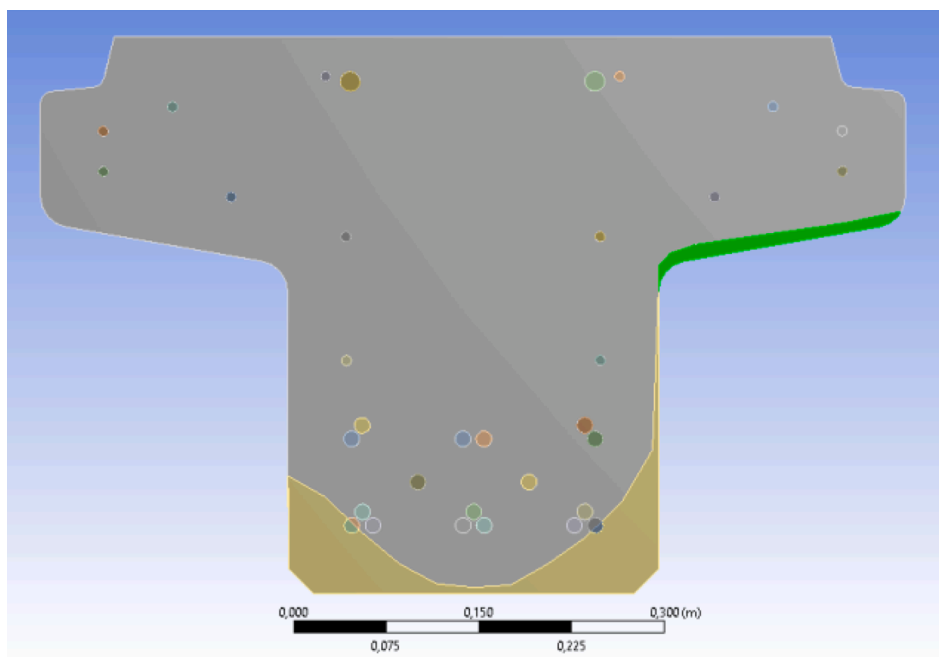
Fig. 14. G-11 beam, 2D model, spalled cross-sections according to on-site records.

- III: On the **G-7 to G-12 bridge beams between B-C supports**, there are visible damages. In addition, there was also concrete spalling due to the vapour pressure and the associated longitudinal cracks. No additional cracks (for example due to traffic reasons) are visible after the fire. The level of carbonation and chloride penetration in the beams is negligible. In the zones affected by spalling and in other parts affected by heat, the strength of the concrete was reduced by an average of 40 %, and the strength of

the outer cold-formed steel bars was reduced by 20–30 %, but their replacement is not justified. The carrying capacity of the damaged bridge beams was reduced by nearly 10 % by the fire. However, it can be stated that the beams with reduced carrying capacity are still suitable for roads with sign “A”. Damaged bridge beams must be restored to their original condition as soon as possible.

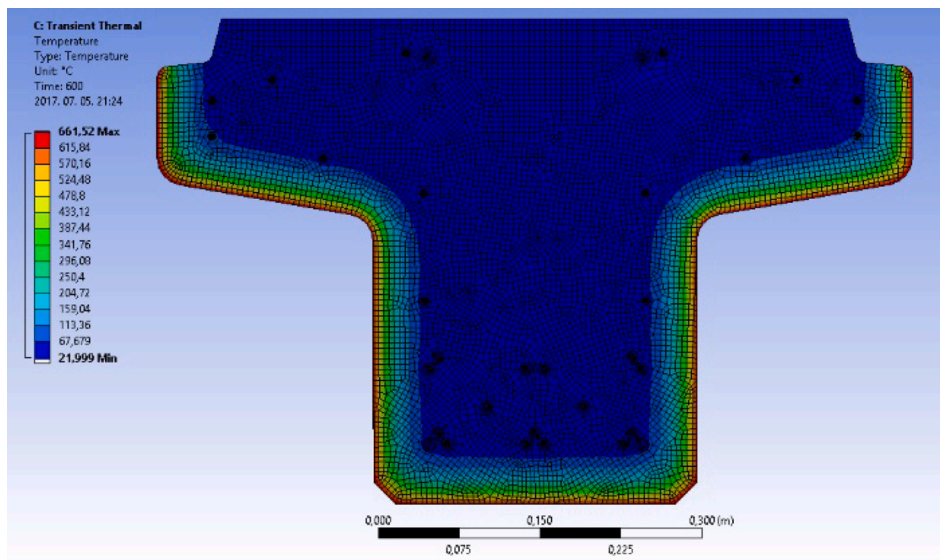
Fig. 15. Position of isotherm lines and prestressed steel bars at the 10th minute at the time of the considered spalling.

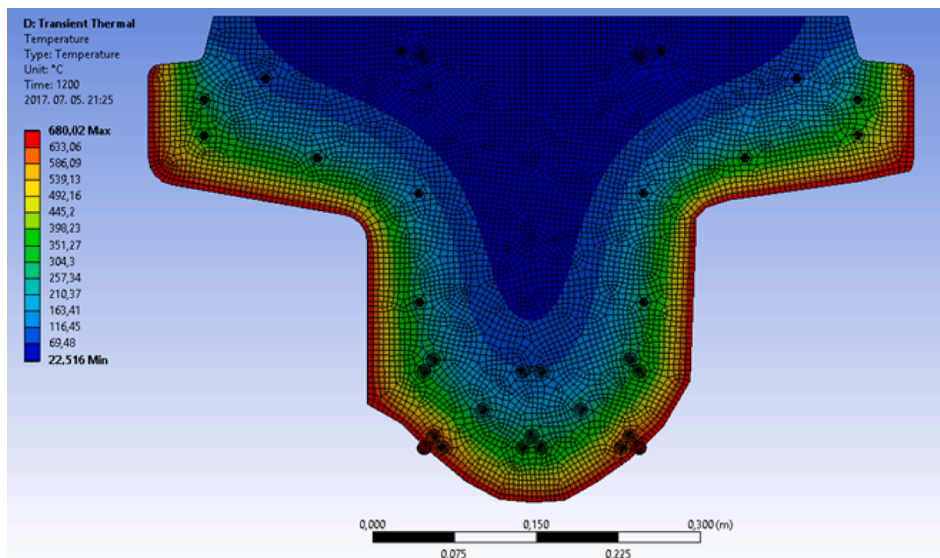
Fig. 16. Position of isotherm lines and prestressed steel bars at the 30th minute with a reduced cross-section.
